Akutan Harbor Project: Delineation of Wetlands on Akutan Island, Alaska

by James S. Wakeley, Chris V. Noble, and Michael J. Bishop

BACKGROUND: The work described in this technical note was done at the request of the Regulatory Branch and the Planning Division of the U. S. Army Engineer District, Alaska, as part of a feasibility study for the potential development of a harbor on Akutan Island in the Aleutian Island chain. Akutan Bay is a steep-sided, glacially scoured, natural inlet on the eastern end of the island (Figure 1). The village of Akutan and a major seafood-processing plant cling to the narrow fringe of level ground at the edge of the fjord. Ocean-going container ships use moorings in the deep water of the bay as they wait to load the frozen catch and transport it to markets throughout the Pacific. But the bay has no natural harbor for the smaller fishing vessels that unload at the facility's dock. The proposed project would excavate a harbor basin in the broad alluvial plain at the head of the bay and would fill and grade adjacent uplands and wetlands to create level areas suitable for harbor-side facilities and associated infrastructure.

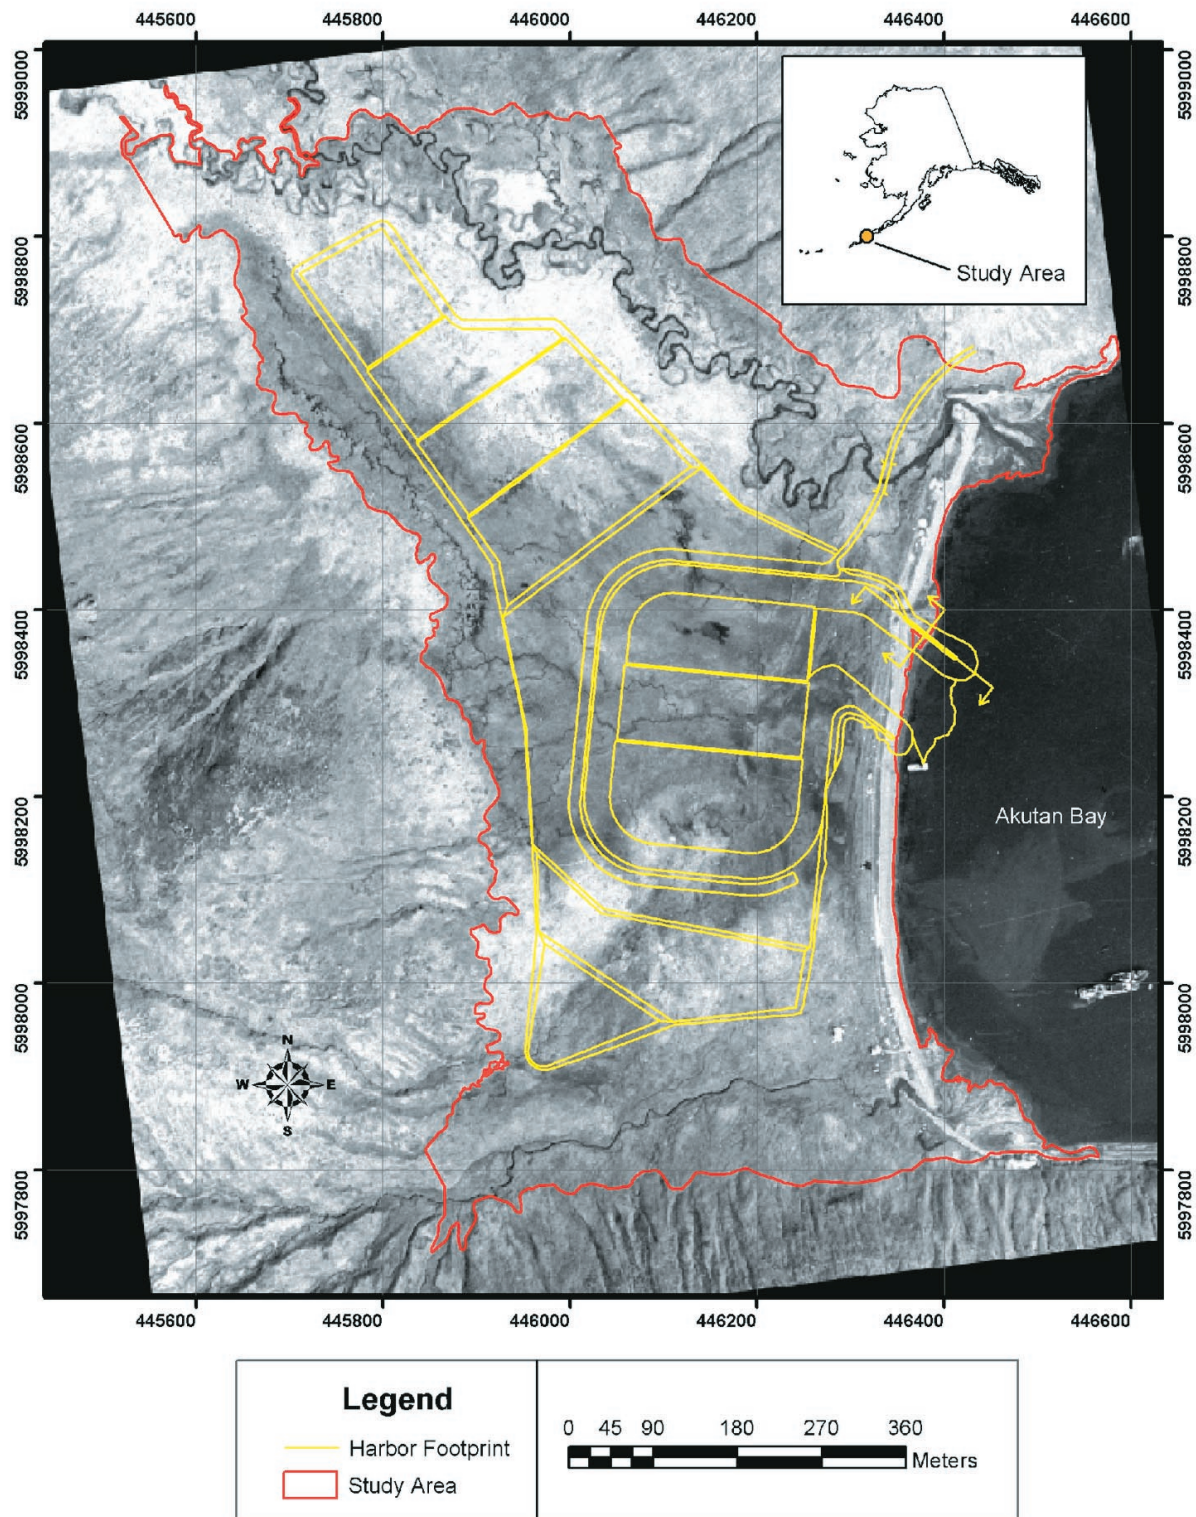
Figure 1. Study area at the western end of Akutan Bay, Akutan Island, Alaska, with the current design for Akutan Harbor and its associated fill area superimposed. Coordinates are based on 200-m Universal Transverse Mercator (UTM) grid ticks. The background photographic image was provided by AeroMap US, Anchorage, AK, and the harbor design by Tryck, Nyman, and Hayes, Inc., Anchorage

At the time the field work was done in August 2000, three project alternatives had been proposed, differing in basin size (12, 15, or 20 acres [4.9, 6.1, or 8.1 ha]) and in the extent of filling for berms and graded areas. In all three plans, the harbor basin would be excavated behind the existing natural beach ridge and would open to the sea by an excavated channel roughly through the middle of that ridge. All three designs included an access road from the north. Later, in April 2001, a modified 12-acre-basin alternative was proposed, which took advantage of detailed topographic data gathered during the field studies. Figure 1 shows the outline of this alternative, which included approximately 55 acres (22 ha) of associated fill.

There were 58 acres (23.5 ha) of wetlands within the footprint of the most recently proposed design for Akutan Harbor and its associated fill area (Figure 1). Placing the proposed harbor in the approximate center of the alluvial plain would result in a considerable impact to the surrounding wetlands. One option to reduce wetland impacts, and perhaps lessen the threat to the north creek complex and its salmon runs, would be to shift the project toward the south and take advantage of upland areas there, particularly to the southeast.

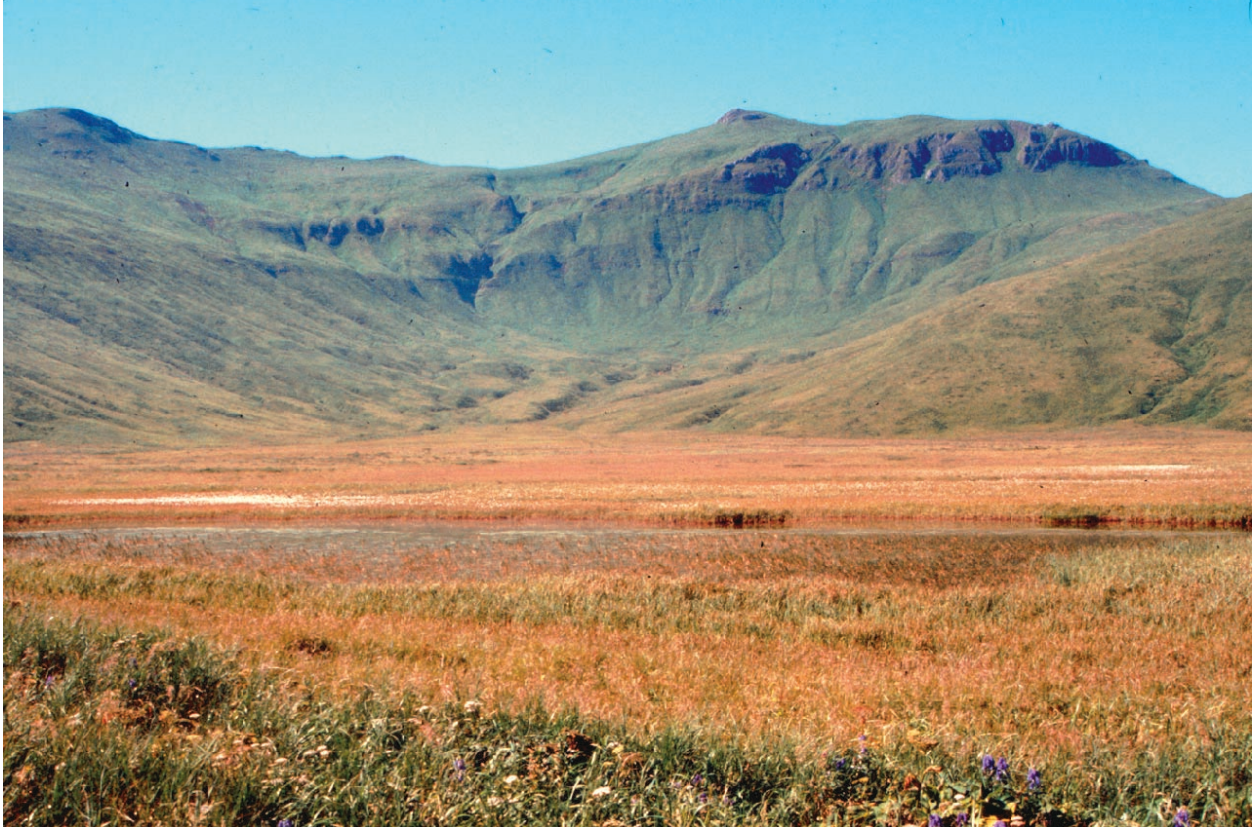
Figure 2. The proposed project area on Akutan Island. Photo was taken looking southwest from the natural beach ridge adjacent to Akutan Bay. The alluvial plain at this point extends approximately 400 m to the toe of the hill slopes in the background

STUDY AREA: The study area for the wetland delineation consisted of the broad, relatively flat plain at the head of Akutan Bay (Figure 2). The area was bounded by the bay on the east and by the lower slopes of the hills to the north and south. On the west, the study area extended inland approximately 1,650 ft (500 m) from the mouth of the south creek and 2,000 ft (600 m) from the mouth of the north creek. In the west-central portion of the site, the study area was bounded by hill slopes. The study area was approximately 150 acres (60 ha) in size and encompassed all of the proposed alternative designs for Akutan Harbor, its related infrastructure, and access road.

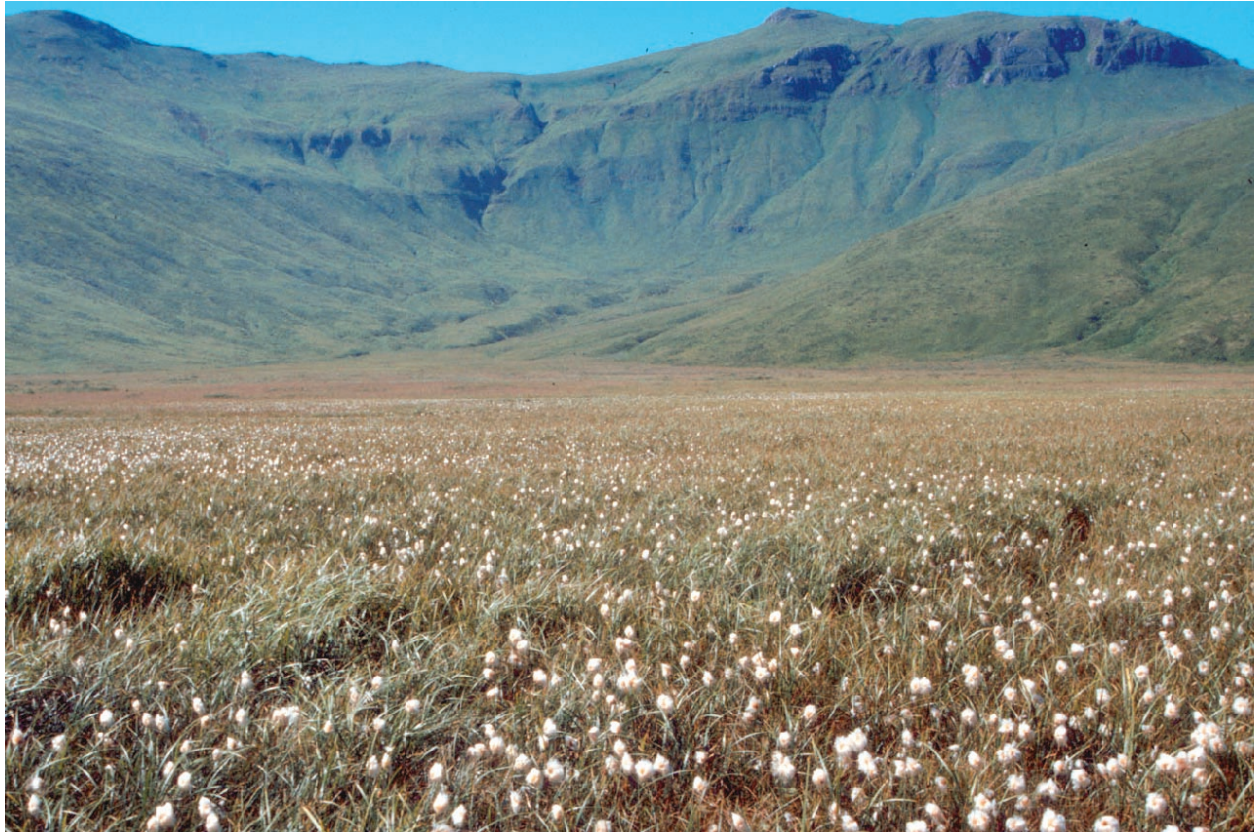
Figure 3. Sedge-dominated community containing cotton-grass as a subdominant

Sedge-dominated communities (Figure 3) ranged from pure stands of Lyngbye's sedge (*Carex lyngbyei*) (OBL) in areas that contained standing water during the site visit to diverse communities of sedges, grasses, broad-leaf herbs, and low shrubs on somewhat drier sites. Depending upon the location, dominant species included Lyngbye's sedge, several-flowered sedge (*C. pluriflora*) (OBL), chestnut rush (*Juncus castaneus*) (FACW), common marsh-marigold (*Caltha palustris*) (OBL), meadow horsetail (*Equisetum pratense*) (FACW), black crowberry (*Empetrum nigrum*) (FAC), hooded ladies'-tresses (*Spiranthes romanzoffiana*) (OBL), seawatch angelica (*Angelica lucida*) (FACU), under-green willow (*Salix commutata*) (FAC) and others. Narrow-leaf and russet cotton-grasses (*Eriophorum angustifolium* [OBL] and *E. chamissonis* [OBL]) were showy subdominants in many sedge-dominated areas.

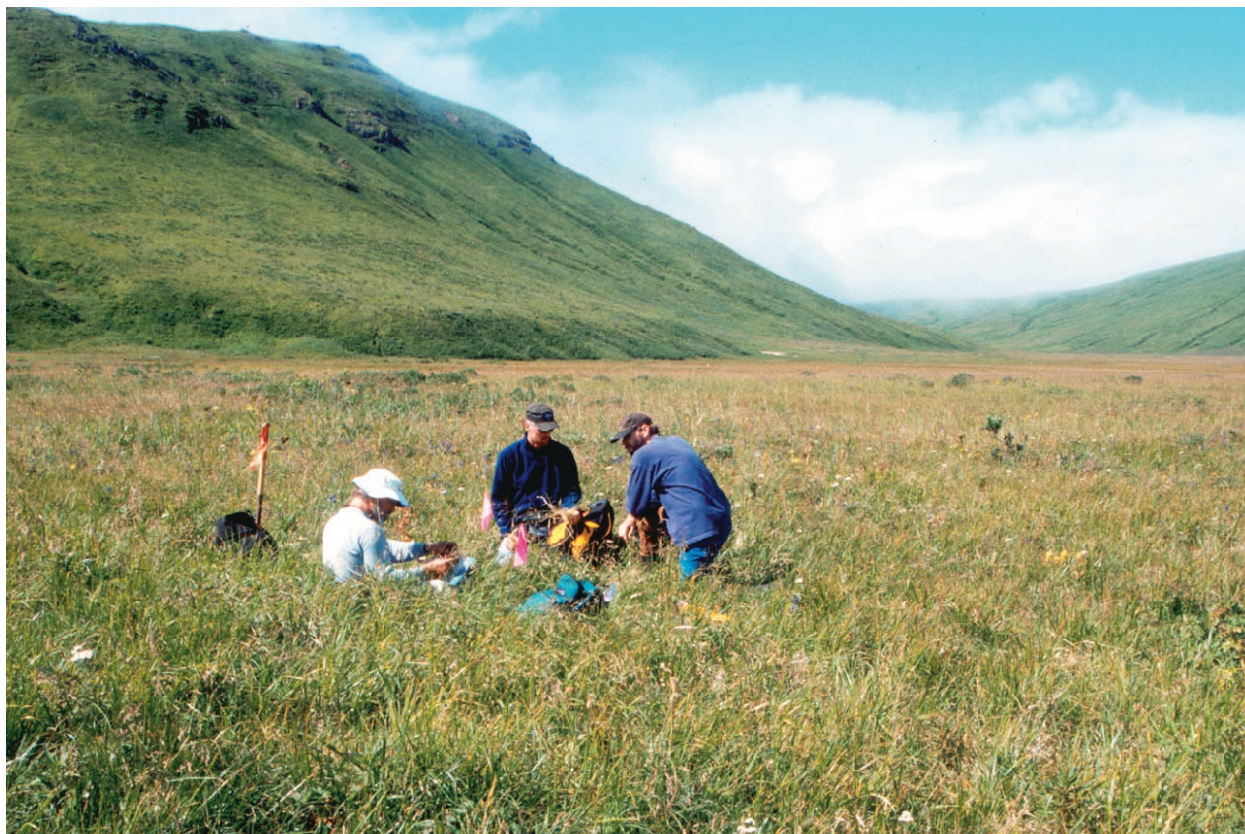
Figure 4. Grass-dominated community

Grass-dominated communities (Figure 4) generally occupied topographically higher and somewhat drier sites than the sedge-dominated communities, but many of the grass-dominated areas still met all three wetland criteria. The predominant grasses were blue-joint reedgrass (*Calamagrostis canadensis*) (FAC) and tufted hairgrass (*Deschampsia cespitosa*) (FAC). Another grass species was dominant at several sampling points but could not be identified due to the lack of an inflorescence at the time of sampling. Other dominant plants in grass-dominated wetland communities included

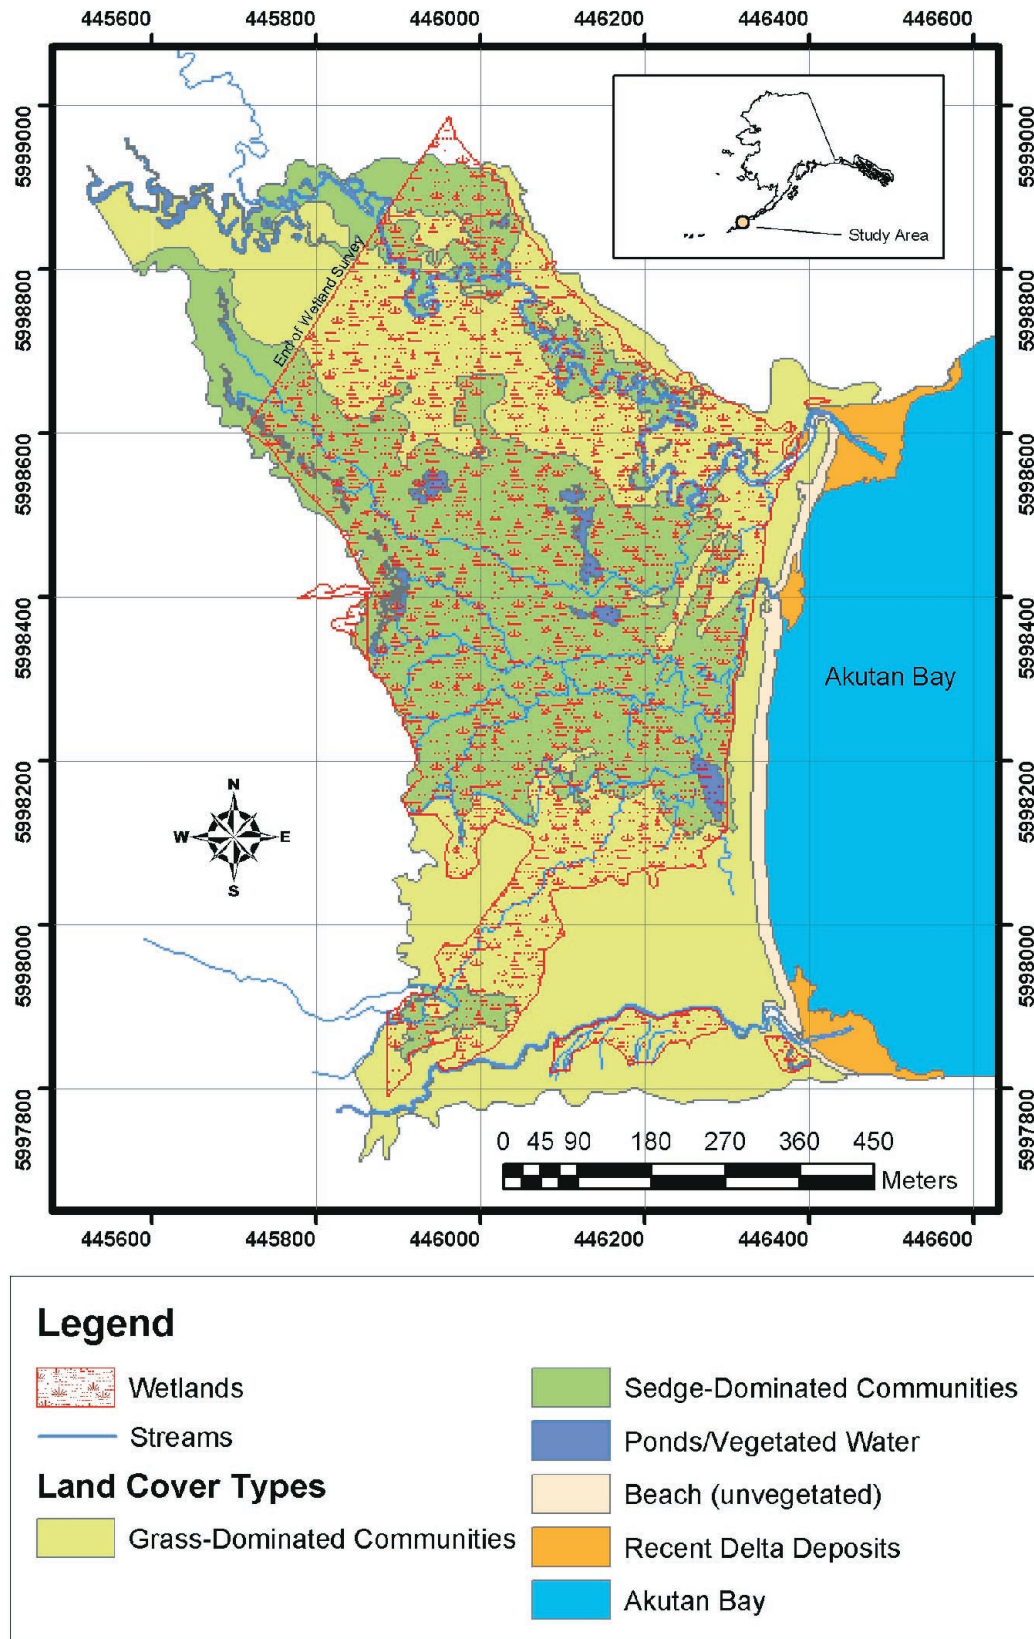
Figure 5. Land cover and wetland boundaries on the Akutan Harbor Project site

WETLAND BOUNDARIES: In general, one vast wetland complex extended from the base of the northern hills, southward across the entire alluvial plain between the bases of the beach ridge on the east and the hill slopes to the west (Figure 5). Occasional seep wetlands extended up the lower slopes of both the northern and western hills. In the southeastern direction, the wetland ended in gradually rising terrain near the site of an old homestead. To the southwest, a wetland corridor extended toward the upper reaches of the south creek. In addition, isolated wetlands were identified near the mouths of both the north and south creeks, and along the right descending bank of the south creek.

CONCLUSIONS: Approximately 95 acres (38 ha) of wetlands were identified in the study area (Figure 5) including virtually all of the sedge-dominated plant communities and the wetter portions of the grass-dominated areas. Nearly all of the northern portion of the study area was wetland, and wetlands continued up the north creek drainage beyond the end of the wetland survey area. In the southern portion of the study area, wetlands were somewhat less extensive, being more or less restricted to a broad drainageway toward the southwest and some isolated wetland patches on the south side of the south creek.

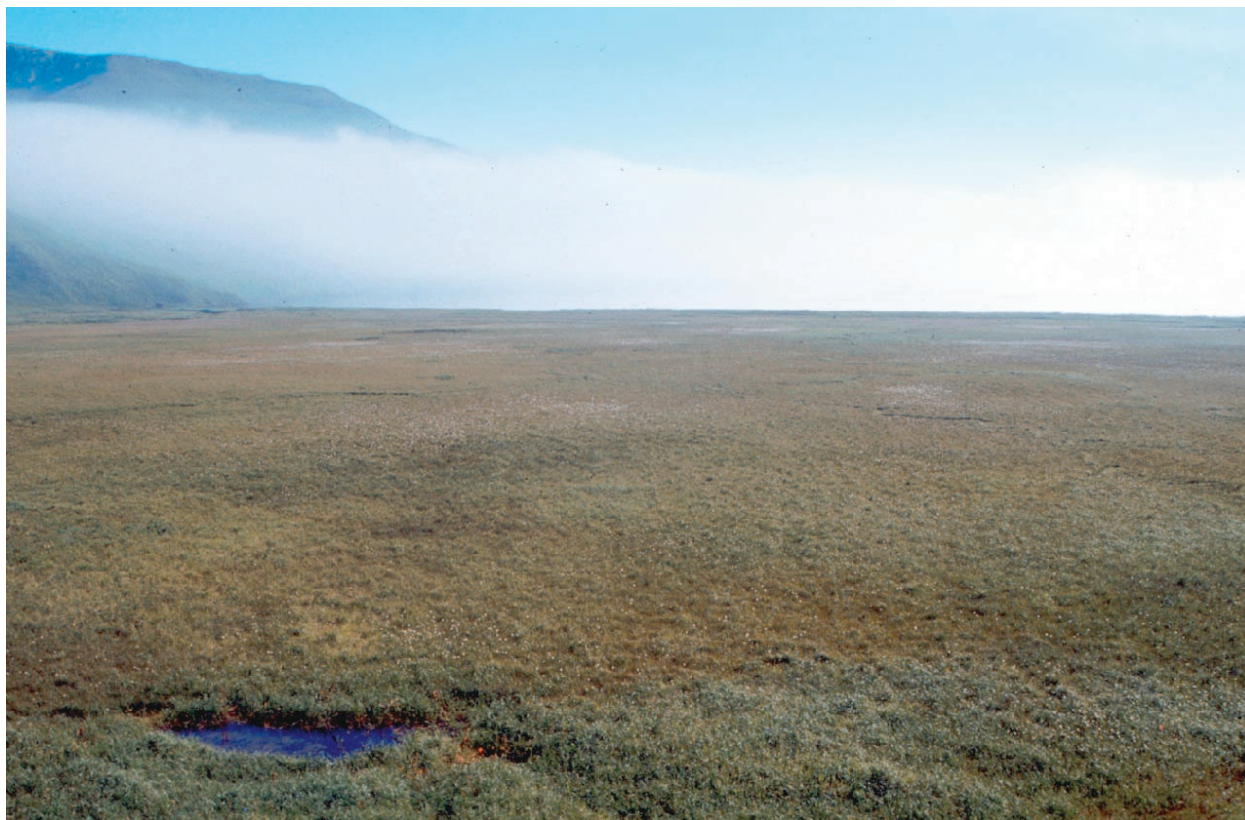
Figure 6. View from the western mountains looking northeast toward a fog-shrouded Akutan Bay. Wetlands on site were nearly all Palustrine emergent (PEM). Small ponds (bottom left) were Palustrine aquatic bed (PAB) or unconsolidated bottom (PUB)

Virtually all of the wetlands identified would be classified as palustrine emergent (PEM) in the Cowardin et al. (1979) classification of wetlands and deepwater habitats. The only possible exceptions were small ponded areas behind the beach berm in the east-central portion of the study area, along the base of the western mountains, and in abandoned meanders along the north creek. Some of these areas lacked emergent vegetation and would be classified either as palustrine aquatic bed (PAB) if they supported submerged or floating vegetation, or palustrine unconsolidated bottom (PUB) if they did not (Figure 6).
